Mangrove Dieback in HA. Kelaa and HDh. Neykurandhoo  
Preliminary Mangrove Survey Report

31<sup>st</sup> August 2020

Ministry of Fisheries, Marine Resources and Agriculture

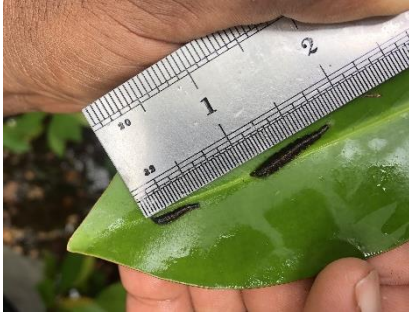
Two distinct insects were observed in significant numbers in both islands. One of them is an insect larva that is singularly found on water surface and floating organic material. It was observed feeding on fallen outer skin of leaf tissue. Preliminary analyses have led us to believe that this belongs to an aquatic fly (Figure 1). However, the effort to grow the larvae to a full adult in laboratory conditions at Hanimaadhoo Agriculture Center did not yield much result.

Figure 1: Larvae found in water (likely aquatic fly)

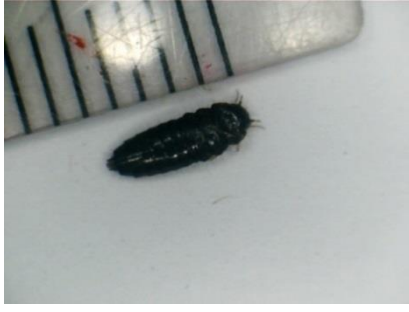
Apart from that, a type of bark borer - a small larva (Figure 2 and 4), was seen in some affected plants between the layers of the bark. Along with these larvae, we sighted a small beetle in some areas inside the bark layers (Figure 3). This beetle is believed to be the adult form of the borer type larvae. Sighting of the pupal form and newly emerging larvae were also observed (Figure 4). This insect and the beetle were only seen from the bark and breathing roots of *Kandoo* and *Bodavaki* plants (Figure 6). In terms of age specificity, there are no differences observed in the level of presence between younger and larger plants. A key observation is that an unusual powdery bark was present at the base of the plant in areas where this borer and beetle were identified. The numbers of both insects were higher in Neykurendhoo mangrove than that of Kelaa's.

Figure 2: Larvae found in bark (borer insect)

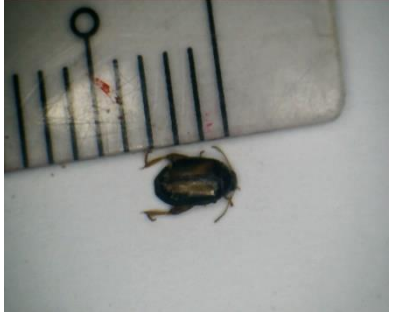
Figure 4: Beetles in tree bark

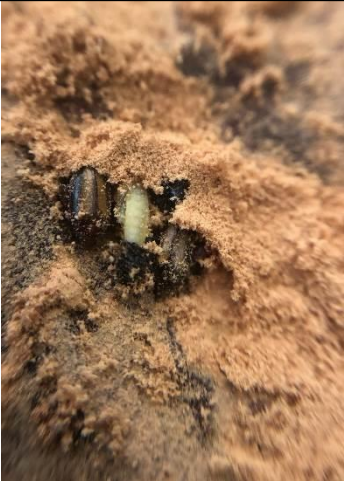
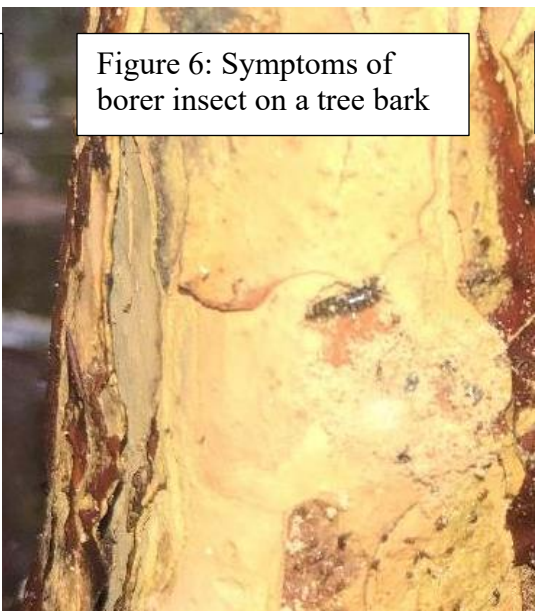
The powdery base of the tree trunks is a good indicator of the feeding behavior of the borer insect. Bark borers have the capacity to cut off the nutrient supply to the upper part of the plants, causing progressive weakening of the plant. Since this insect was observed in all of its lifecycle, it is assumed to be well established and has been present in the habitat for a while. Their prevalent presence in *Bruguiera spp* (*kandoo* and *bodavaki*) plants indicates that it might be host specific. Moreover, the absence of these insects in the areas that are already dead indicates that it is moving to viable hosts. It could be argued that the sudden surge of this insect might be due to the low water level during the Dec- April period, enabling more access to the lower, more fragile part of the plants for an extended period of time.

Figure 6: Symptoms of borer insect on a tree bark

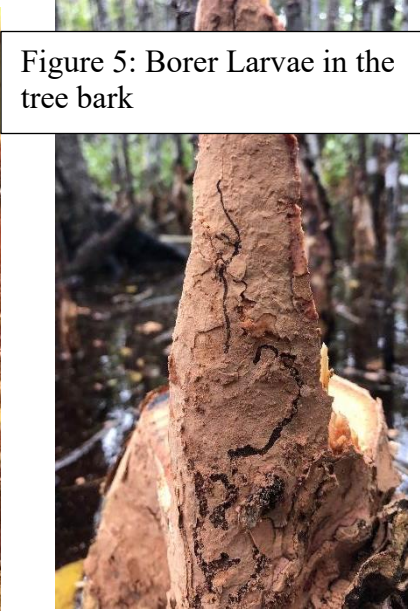
Figure 5: Borer Larvae in the tree bark

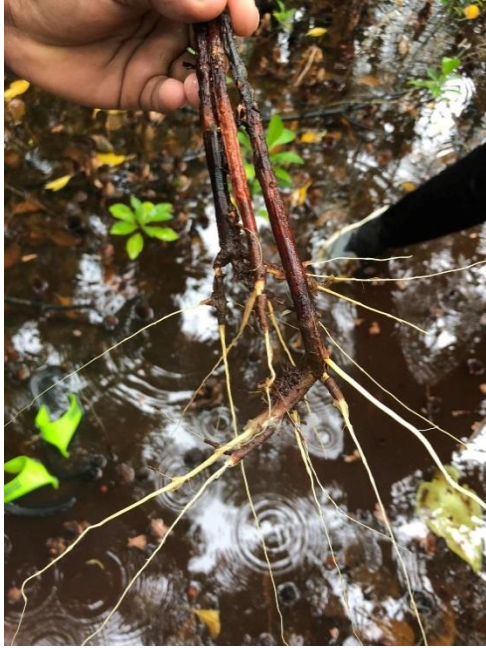
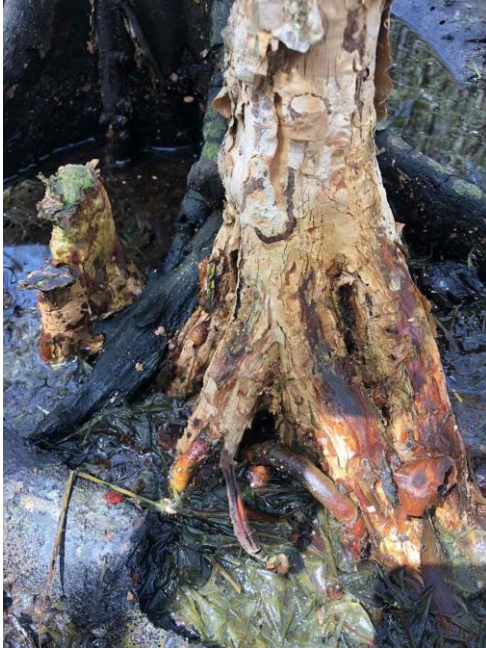
It is noted that there was a rotting odor coming from the dead tree parts, especially from the roots of the plants in Kelaa (figure 7 and 8). This could be a result of bacterial or fungal damage. Moreover, the damaged roots of these plants, both at the surface level and under water, were observed to be soft and hollow.

water temperature thus prolonging anaerobic conditions. The rotting odor in root samples taken from Kelaa mangrove could be due to an infection of either bacterial or fungal origin escalated by the heavy application of BTI. BTI, being a biological pesticide requires a healthy environment to be active. In poor conditions, it could contaminate the water and deteriorate growth promoting factors. However, there is no direct indication that this is the primary reason for the onset of the rot. It is well known that poor water quality coupled with high temperature is an escalating factor for water based fungal or bacterial pathogens. This is supported by the fact that this odor and associated root rot samples were not present in Neykurendhoo mangrove where BTI was not reported. Due to the irregularity of root rot samples observed, this infection might be a secondary factor that takes advantage of the large number of dead plants rather than the main cause of plant death.

Figure 7: Symptoms of root rot in *Bruguiera cylindrica* – Kelaa

Figure 8: Symptoms of root rot in *Bruguiera cylindrica* – Kelaa

It is important to clear areas of the mangrove where large number of dead and decaying matter is observed. Especially for Kelaa, an organized plant removal effort might be beneficial to promote growth of regenerating plants. This is also to limit further spread of root rot and reduce the introduction of potential predatory or pathogenic species.
